**ELECTRICAL SAFETY AUTHORITY WARNS SPORTS FIELD OPERATORS ABOUT ELECTRICAL SAFETY HAZARDS WITH OLDER ELECTRICAL AND LIGHTING EQUIPMENT**

May 28, 2008

SAFETY ALERT

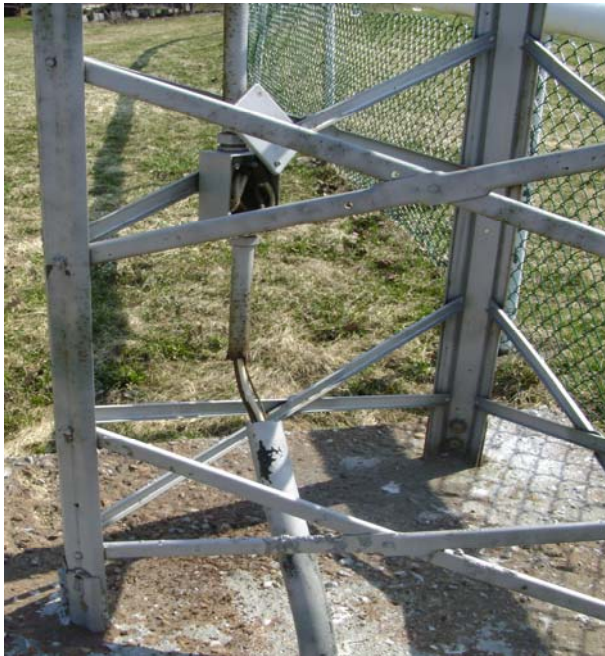
One of the main concerns is the use of electrical metallic tubing (EMT) as the raceway in light standards or tower installations. EMT was commonly used a number of years ago as raceway for electrical wiring in outdoor installations such as sports field light standards. However, EMT can become rusted and break apart where it has been used as a conduit in exposed installations. The EMT has a tendency to shear off at the point where it exits the concrete base leading up into the light tower. This deteriorated conduit can pose a shock hazard to the public through loss of bonding and exposed conductors.

- In some instances there has been no bond wire used in the original installation.
- Electrical metallic tubing (EMT) is rusting and breaking apart.
- The EMT can shear off at the point that it exits the concrete base leading up into the light standard.

1. Check the condition of all conduits to ensure no breaks or cracks.
2. Look for conduit that has sheared off at ground level
3. Ensure that there is proper grounding and bonding of all electrical equipment.
4. Assess the integrity of the EMT. If deterioration has occurred, the EMT should be replaced with an approved conduit rated for exterior use.
5. Ensure connection boxes are not damaged nor have missing covers.
6. Conduct annual routine inspections of the structural integrity of light standards and towers. ESA Inspectors have identified severe cracks and rust deterioration in some light poles.
7. Repair all identified deficiencies immediately.

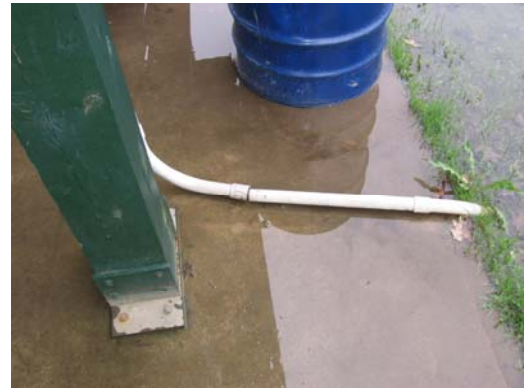
- The Ontario Electrical Safety Code prohibits the use of EMT conduit in wet environments.
- Many of the electrical panels are protected by wooden enclosures which are not weather-proofed and tend to deteriorate with outdoor exposure.
- Many of the electrical panels are not locked even though they have the capability of being locked.
- Most of the outdoor outlets are not GFCI protected. This poses a potential hazard where the public (and children) have unsupervised exposure to the electrical outlets. There is no way to ensure the condition of the electrical cords being used by the public in these receptacles.

ESA recommends all outdoor electrical receptacles are GFCI protected and tested monthly as per manufacturers' instructions.

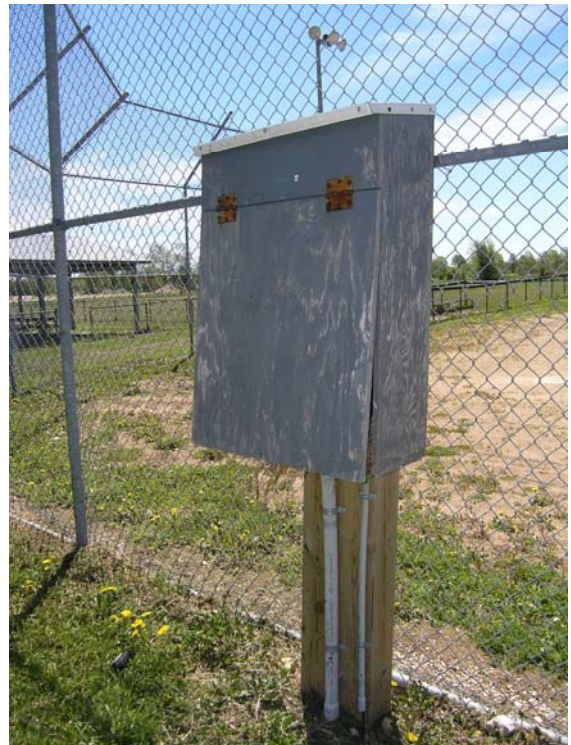
Another major concern is the condition of the electrical panels. Many of the wooden or sheet metal enclosures protecting the electrical panels from exposure to the weather have deteriorated over time and now allow the weather to infiltrate the electrical equipment inside. Many of the enclosures are not locked, making it easy for the

public to access the equipment and the panels. Equipment that is rusting or has holes or missing panel fillers could make live connections accessible to the public.

- Many of the electrical panels are rusting or have openings as a result of missing panel fillers or knock out fillers. This exposes the live bus to anyone putting their hands on or near the panel.

1. Check the condition of the enclosure protecting the electrical equipment from the weather.
2. Check the condition of the electrical panels and equipment. Ensure there are no holes in the panels or missing panel fillers that would expose the public to a shock hazard. Check for deterioration due to rust.
3. Ensure that the panel enclosure can be locked, and that it is locked.
4. Ensure the copper ground wire has not been removed (copper wire is at high risk of theft).
5. Repair all identified deficiencies immediately.
