Important Product Safety Bulletin

Eaton/ Cutler-Hammer Brand Labeled Rotary and Toggle Disconnect Switches

A supplier defect in the disconnect switch could allow one pole to remain energized when the switch is in the OFF position,

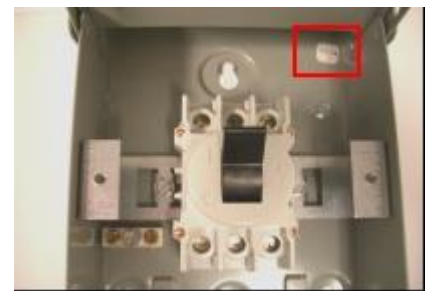
DPU362R

Step 4: The date code is listed on the upper right corner inside the case.

Step 5: If the A/C disconnect date code falls between Week 1 of 2007 and Week 52 of 2007 (F701& and F752&) then the date code of the switch must be checked (Continue to Step 6). If the A/C disconnect date code does not fall in the stated time period, the unit can be operated normally. The circuit can be re-energized.

Step 6: Remove the toggle switch using the din rail release tab mechanism located on the line side of the switch. Inspect the date code located on the back of the switch as outlined in Appendix B. If date code on the switch falls between Week 1 of 2007 and Week 50 of 2007 (1 07 and 50 07) then the switch must be replaced. The replacement switch is C362TW60. If the date does not fall in the stated time period, reinsert the switch and cover plate. The unit can be operated normally. The circuit can be re-energized.
